Wilson Inlet Foreshore Flora Survey

March 2011

Report written by Elissa Stewart; Wilson Inlet Catchment Committee for Department of Water
Map created by Yvette Caruso; Denmark Shire

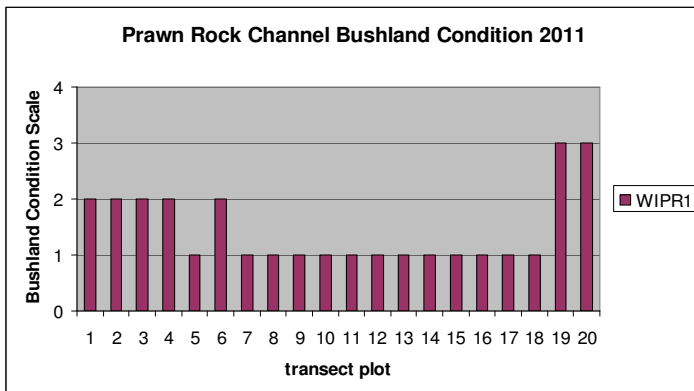
Figure 1.1 Prawn Rock Channel Bushland Condition

Bushland Condition: Overall the Bushland Condition was generally “Poor” or “Degraded”, with incursion of introduced *Paspalum spp.* (Couch) and *Pennisetum clandestinum* (Kikuyu) grasses throughout the area. Only the last 2 inland meters of the transect line (plot 19 and 20) showed improvement to “Good” condition (see figure 1.1). This coincided with proximity to/reduction in water level.

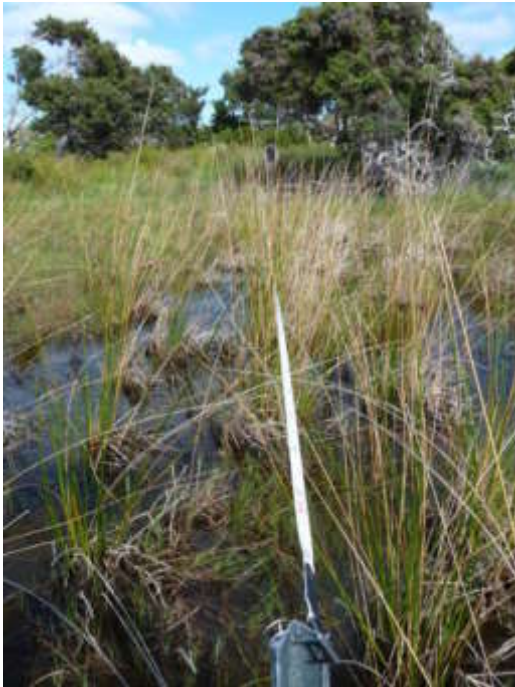
Photo 1.1 Prawn Rock Channel transect line

Flora species: Dominant native species along the transect line was the sedge *Juncus kraussii*, although it was patchy to absent in the middle swale section (plot 10 – 18) where the water levels ranged between 40cm - 55cm. In general, when water levels exceeded 40cm, native flora species were absent, while couch and kikuyu were still present. The exceptions to this were in subplot 16.1, 17.1 and 17.2 where 1 - 3 *Baumea juncea* plants were present and sub-plot 14.2 in which no vegetation was found.

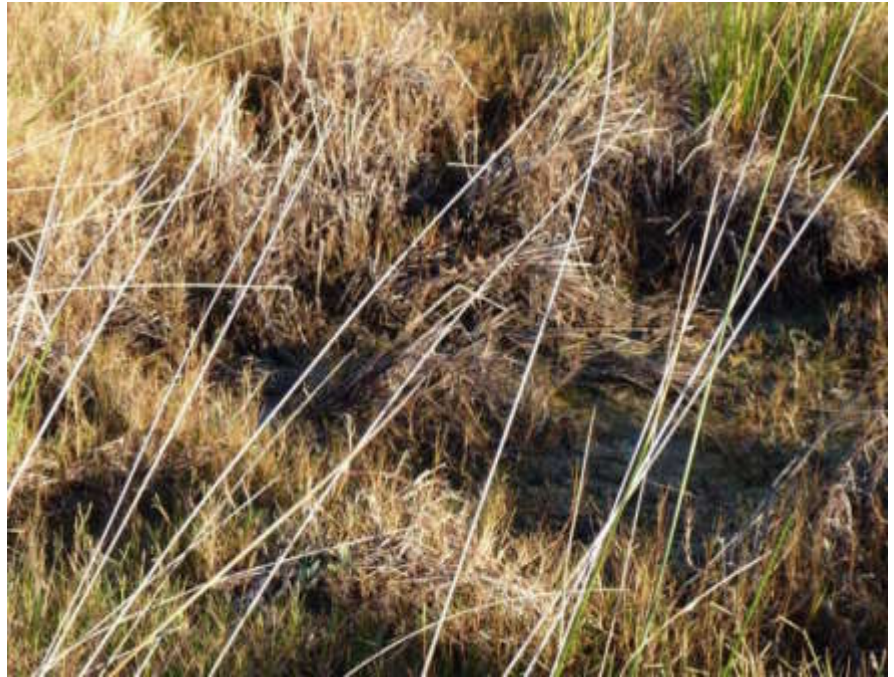
It was noted that along and around the transect, particularly in deeper water sections, there were a number of dead clumps of a native sedge species (see Photo 1.2), which the couch was growing over. This may be why the couch could survive in the deeper water sections of the transect. A number of dead *Melaleuca* species were also seen in the vicinity; however these deaths occurred over a number of years ago due to drainage/road works nearby (pers. comm. Shire of Denmark).

Photo 1.2 Prawn Rock Channel; example of dead sedge clumps and couch invasion

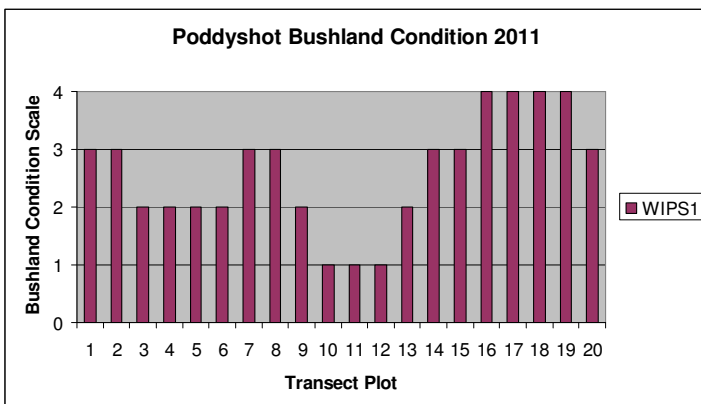
Figure 2.1 Poddysht Bushland Condition

Bushland Condition: The Poddysht transect varied greatly, ranging from “Degraded” to “Very Good” (see figure 2.1). “Very Good” condition was only recorded along the latter, inland section of the transect; plots 16 – 19. “Good” condition was recorded throughout the transect with no general trend i.e. plots 1, 2, 7, 8, 14 and 20. “Poor” and “Degraded” conditions were similarly distributed. The lower condition grades were mainly due to incursion from the invasive grass species, *Paspalum spp.* (Couch) and *Pennisetum clandestinum* (Kikuyu). There was also a smaller population of other invasive weeds including *Chenopodium spp.* (Goosefoot).

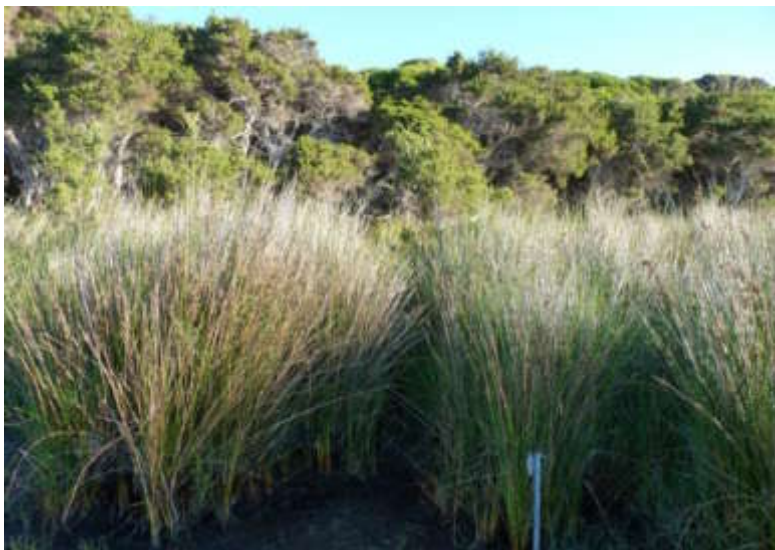
Photo 2.1 Poddyshot transect (note original photo was lost, displayed photo taken mid March 2011. At time of survey water level was 9cm at shoreline marker.

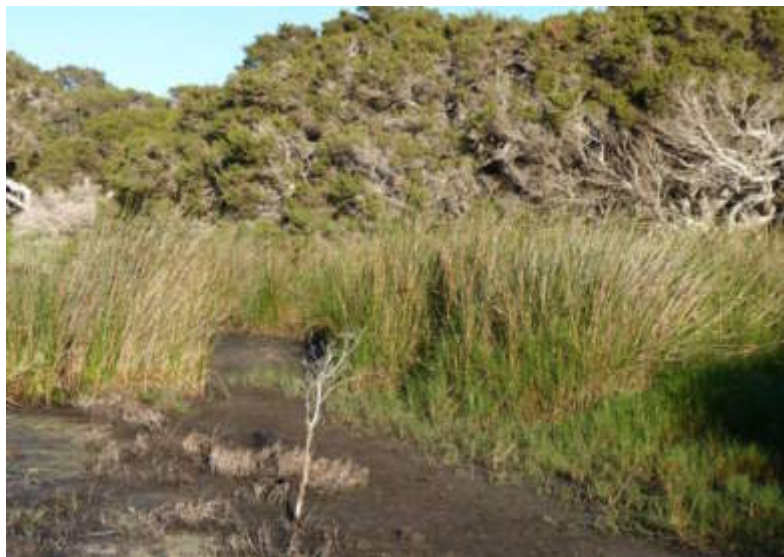
Flora species: *Juncus kraussii* and *Ficinia nodosa* were the dominant under storey native species, while the upperstorey consisted of *Melaleuca cuticularis* from plot 13 to 20. There was evidence of young *Melaleuca spp.* death in area within the inundation zone (see photo 2.2).

Photo 2.2 Poddyshot, dead *Melaleuca spp.* (note; was taken mid March 2011. At time of survey Melaleuca was partially under water).

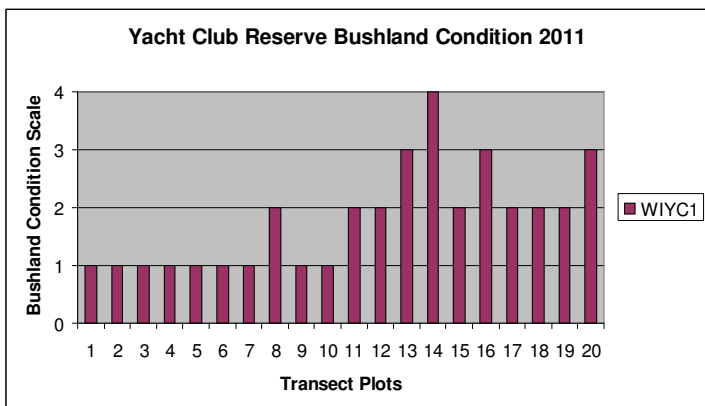
Figure 3.1 Yacht Club reserve Bushland Condition

Bushland Condition: Generally “Poor” to “Degraded” along the length of the transect (see figure 3.1). Exceptions were plots 20, 16, 14 and 13 which were graded “Good”, “Good”, “Very Good” and “Good”, respectively. As mentioned previously, where there had been recent and current inundation there was little understorey and a number of weeds evidence leading to Bushland Condition generally graded as “Degraded” (plot 1 – 10), with the exception of plot 8 with a grade of “Poor”.

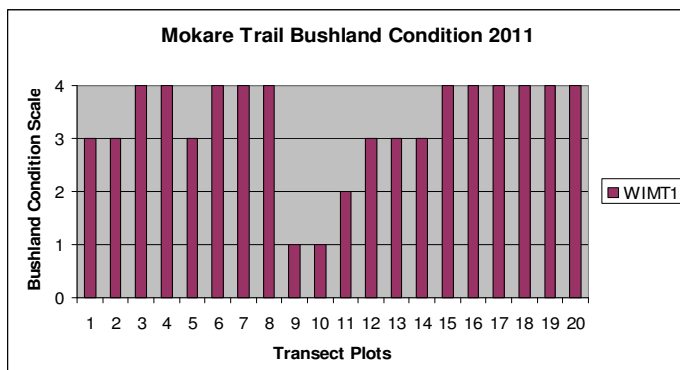
Figure 4.1 Mokare Trail Bushland Condition

Bushland Condition: Fairly consistent over the transect line with “Good” - “Very Good” condition in all except three plots (9, 10 and 11) (see figure 4.1). Mokare Trail intersected the transect on plots 9 and 10 and half of plot 11, hence the “Degraded” Bushland Condition score for plots 9 and 10 and “Poor” for plot 11. Minimal weed incursion by *Paspalum spp.*(Couch) occurred primarily at the foreshore bank edge and a small number of *Eragrostis curvula* (African Lovegrass) and *Chenopodium spp.* (Goosefoot), occurred near the Mokare trail edge (plot 11).

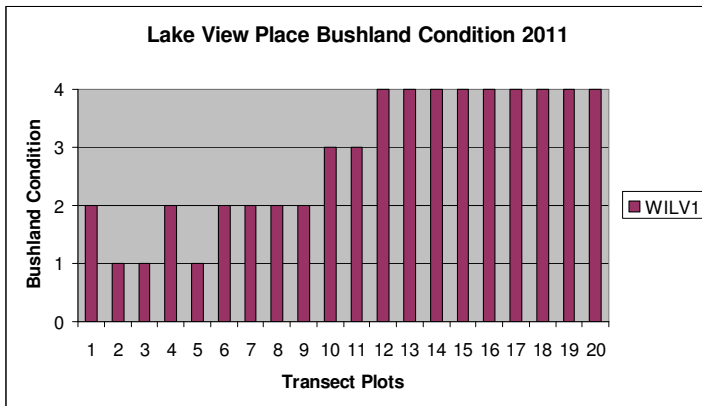
Figure 5.1 Lake View Place Bushland Condition

Bushland Condition: Ranged from “Degraded” to “Very Good” (see figure 5.1). From the shoreline end, (plots 1 – 9), the condition was “Degraded” - “Poor” with invasion by *Paspalum spp.* (Couch), *Chenopodium spp.* (Goosefoot) and *Conyza spp.* (Fleabane). From plot 10 Bushland Condition improved with plots 10 and 11 recording “Good” and 12 – 20 “Very Good”.

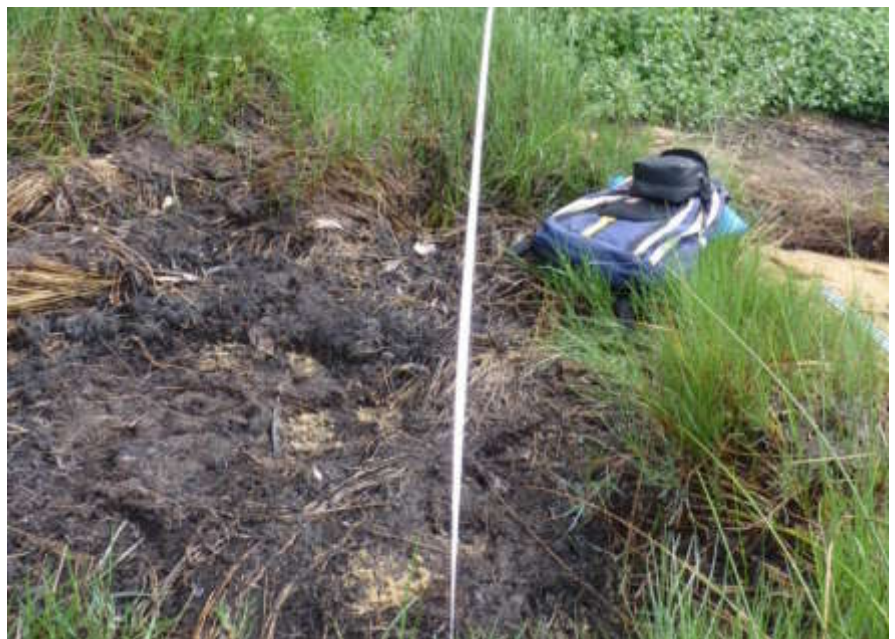
It was also noted that there were a number of dead sedges in and around some of the shoreline end plots (see Photo 5.2).

Photo 5.2 Example of dead sedges and other vegetative matter

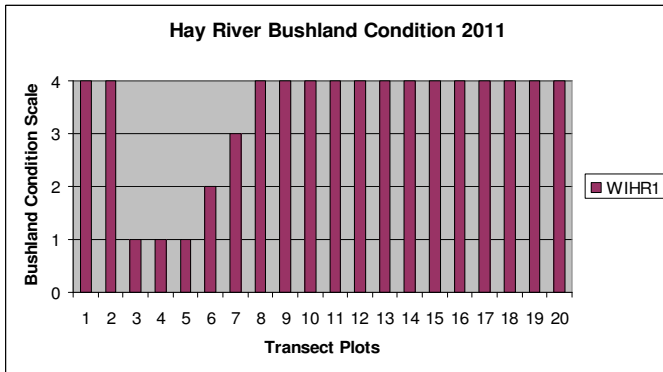
Figure 7.1 Hay River Bushland Condition

Bushland Condition: Generally “Very Good” with only plots 3, 4, 5, 6 and 7 graded “Degraded”, “Degraded”, “Degraded”, “Poor” and “Good” respectively (see figure 7.1). There was minimal weed incursion in the “Degraded” and “Poor” conditioned plots, however a vehicle track ran through plots 3, 4 and 5 which caused a high level of disturbance and changes to vegetation structure.

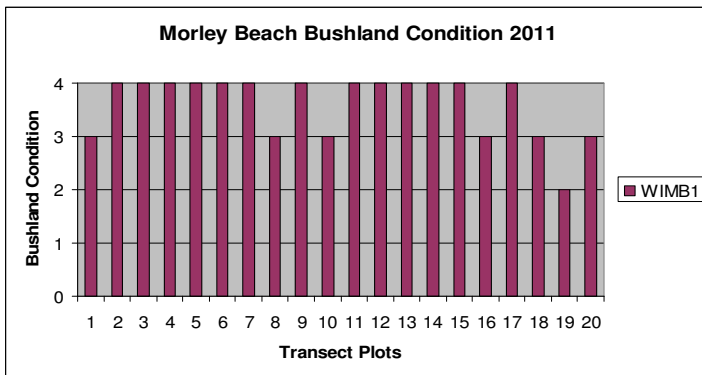
Figure 8.1 Morley Beach Bushland Condition

Bushland Condition: Both ends (shoreline and inland ends) were “Poor” (plots 1, 19 and 20) with all remaining plots in either “Good” or “Very Good” condition (see figure 8.1). There was a small amount of *Chenopodium spp.* (Goosefoot) incursion in the area as well as evidence of disturbance to the shoreline fringing vegetation from vehicles accessing and driving along the beach.

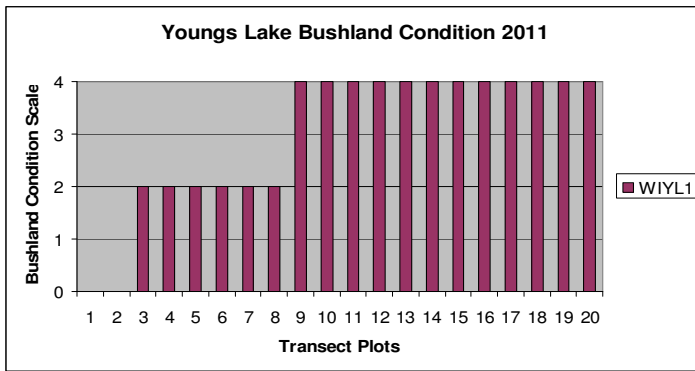
Figure 9.1 Youngs Lake Bushland Condition

Bushland Condition: Was “Very Good” (plots 9 -20) in the latter inland section of the transect (see figure 9.1). Plots 1 and 2 recorded no vegetation and were underwater, hence, “not applicable” was recorded. Further along the transect plots 3 – 8 recorded “Poor” condition with little vegetative matter.

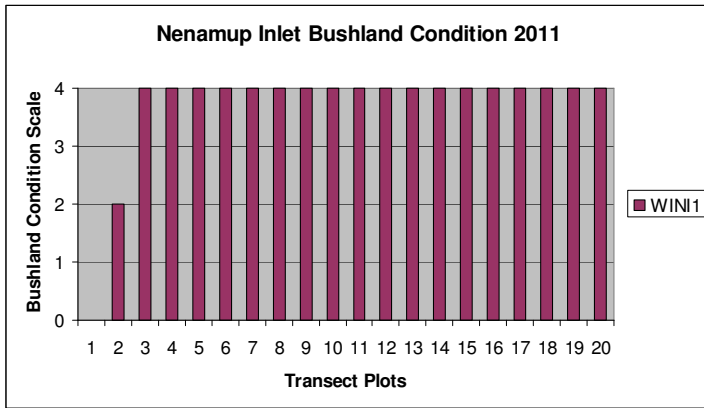
Figure 10.1 Nenamup Inlet Bushland Condition

Bushland Condition: Was “Very Good” except for the two plots (plots 1 and 2) closest to the shoreline transect end (see figure 10.1). Plot 1 recorded “not applicable” due to no vegetation and complete water inundation. Plot 2 recorded a “Poor” bushland condition with 3 *Juncus kraussii* plants in the plot.

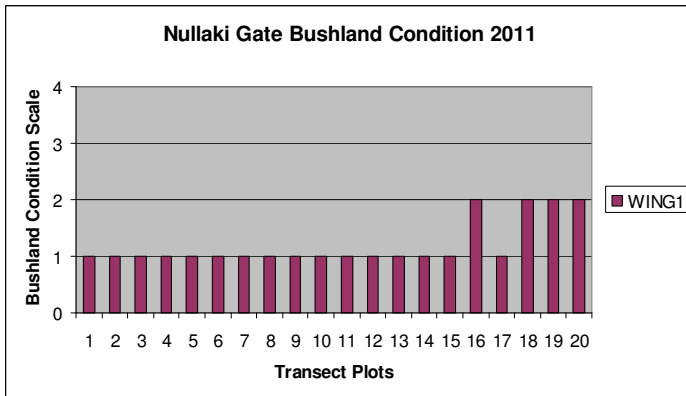
Figure 11.1 Nullaki Gate Bushland Condition

Bushland Condition: The transect was fairly degraded, with plots 1 – 17 recording “Degraded” condition (except for plot 16) and plots 18 – 20 recording “Poor” (see figure 11.1). The site showed a large infestation of *Paspalum spp.* (Couch) and little to no native vegetation. It was noted that the site showed evidence of past informal camping which may be contributing to the high level of disturbance to the area along with other factors.

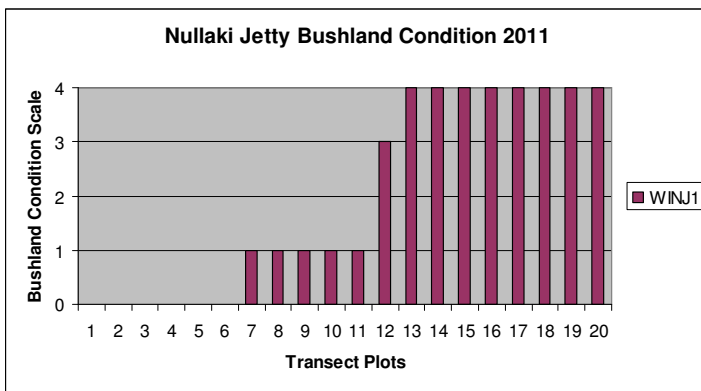
Figure 12.1 Nullaki Jetty Bushland Condition

Bushland Condition: Improved traveling away from the shoreline transect end (see figure 12.1). Plots 1 -6 were “not applicable” due to being underwater and having no vegetation. Plots 7 – 11 were “Degraded”, plot 12 “Good” and plots 13 – 20 “Very Good”. The main invasive species along the “Poor” section of the transect were *Paspalum spp.* (Couch) and *Chenopodium spp.* (Goosefoot).
