Wilson Inlet Foreshore Flora Survey

March 2011

Report written by Elissa Stewart; Wilson Inlet Catchment Committee for Department of Water
Map created by Yvette Caruso; Denmark Shire

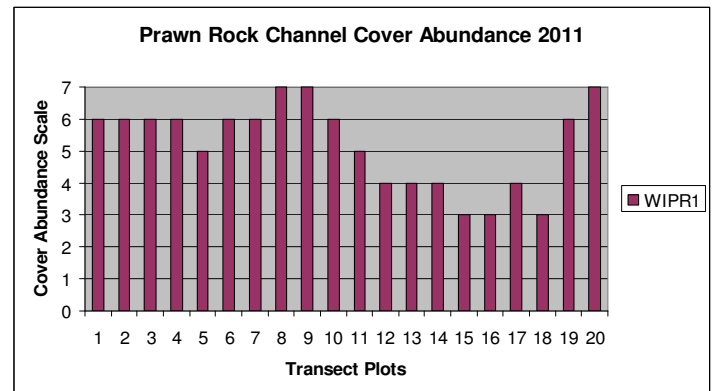
Figure 1.2 Prawn Rock Channel Cover Abundance

Cover Abundance: Ranged from 3 to 7 cover along the transect line (see figure 1.2). There appeared to be no correlation between the Cover Abundance values and water levels as any one Cover Abundance value varied considerably over differing inundation levels.

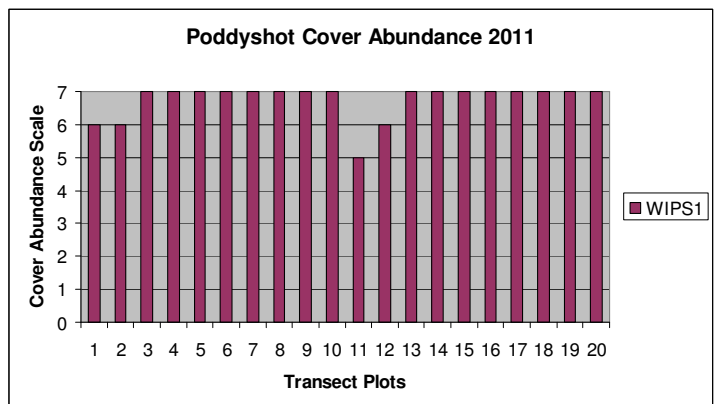
Figure 2.2 Poddysht Cover Abundance

Cover Abundance: Fairly uniform along the transect line from 5 to 7, with the majority of plots recording 7 (75-100% cover) (see figure 2.2). The plots that recorded 5 and 6 Cover Abundance coincided with the only recordings of water inundation (0.5cm to 9cm). Upperstorey cover began at plot 13 with stands of *Melaleuca cuticularis* and still supported understorey cover of 45% - 100%.

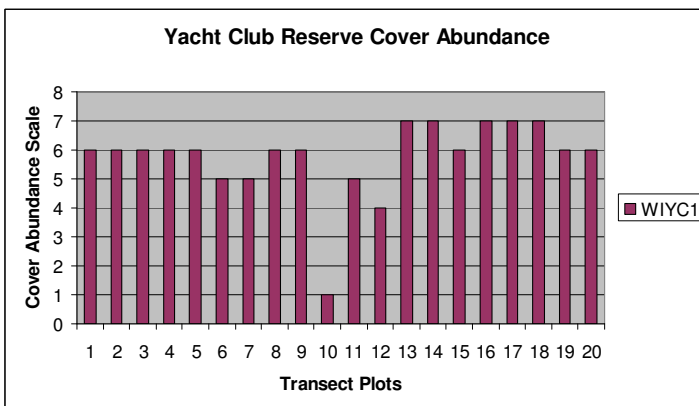
Figure 3.2 Yacht Club Reserve Cover Abundance

Cover Abundance: Plots 1 to 9 recorded a value of “6” (see figure 3.2), primarily from upperstorey cover by *Melaleuca cuticularis* and *Melaleuca raphiophylla*. The understorey for these plots was generally negligible (less than 5% cover) except for plot 7 and 8 where weed incursion including *Chenopodium spp.* (Goosefoot) and *Sonchus spp.* (Sowthistle) had occurred. Further inland (plots 11 to 20) along the transect, the understorey cover increased to 20% - 100%. Plots 13 – 20 all recorded abundance cover of 7 with the exception of plot 15 which recorded a cover of 6. Plots 10, 11 and 12 recorded covers of 1, 5 and 4 respectively. In these plots there were gaps in the upperstorey and <5% to 50% understorey cover.

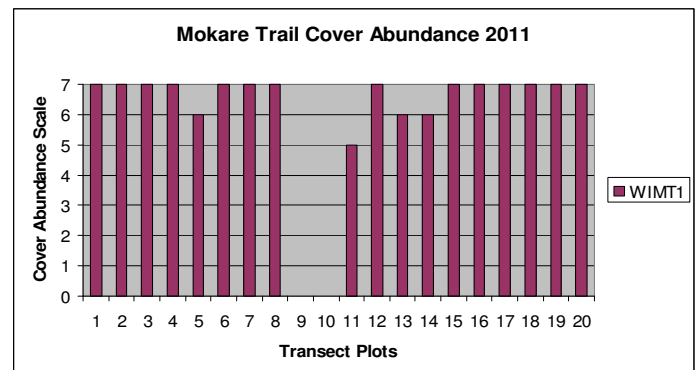
Figure 4.2 Mokare Trail Cover Abundance

Cover Abundance: Was also fairly uniform with grades of 6 and 7 along the transect, excluding where the Mokare trail intercepted the transect (see figure 4.2). Plot 11 recorded a value of 5 and plots 9 and 10 were “not applicable”. The cover was made up thick understorey and open upper canopy.

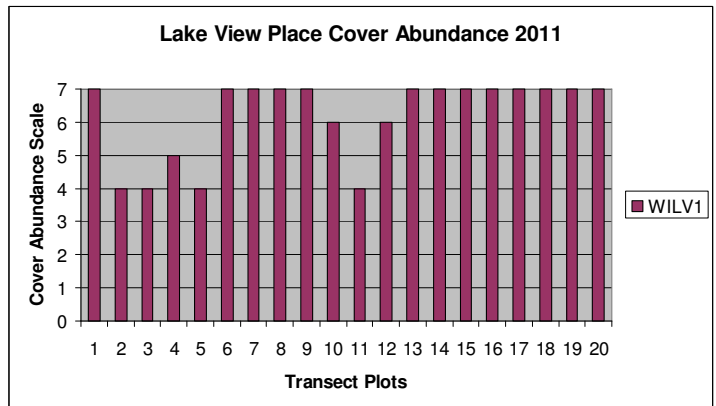
Figure 5.2 Lake View Place Cover Abundance

Cover Abundance: Was generally high with 15 out of the 20 plots recording cover of 6 and 7 (see figure 5.2). Plots 2, 3, 5 and 11 recorded cover of 4 and plot 4 recorded cover of 5. A high percentage of the cover for shoreline end plots was from invasive flora species as described above in Bushland Condition section.

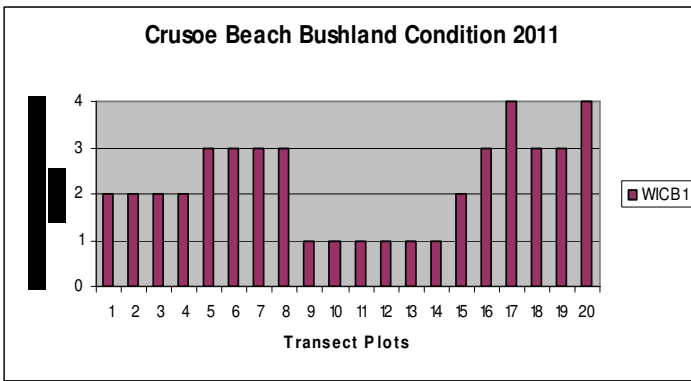
Figure 6.1 Crusoe Beach Bushland Condition

Bushland Condition: Varied greatly over the transect, ranging from “Degraded” to “Very Good” (see figure 6.2). Plots 2,9,10,11,12,13 and 14 recorded “Degraded” condition. Plots 11 – 13 were bare sand except for 2 plants on plot 12. Plots 1, 3, 4 and 15 recorded “Poor” condition with *Paspalum spp.* (Couch) and a small number of other invasive flora species present. Plots 5, 6, 7, 8, 16, 18 and 19 recorded “Good” condition and plots 17 and 20 recorded “Very Good” condition.

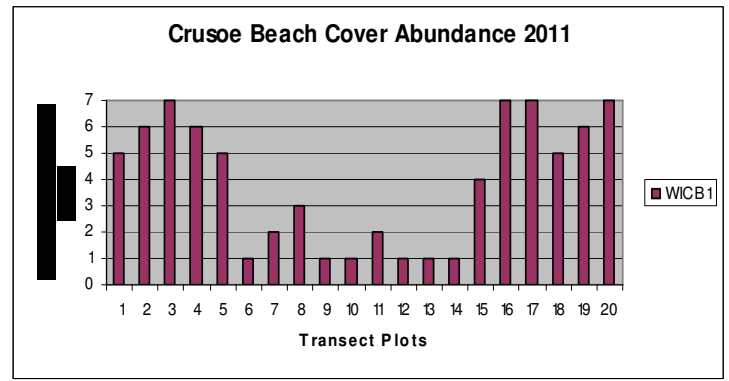
Figure 6.2 Crusoe Beach Cover Abundance

Cover Abundance: Ranged along the entire Cover Abundance scale over the length of the transect (see figure 6.2). Plots 1 – 5 recorded values of 5 - 7, while plots 6 – 15 recorded values of 1 – 4. Plots 16 – 20 recorded cover values of 5 – 7. The higher cover along the shoreline section is in the main part from a *Melaleuca cuticularis* tree at plot 3.

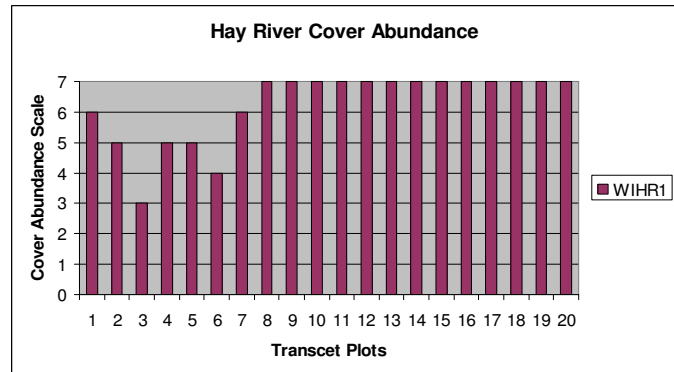
Figure 7.2 Hay River Cover Abundance

Cover Abundance: Was fairly uniform along the transect with plots 8 – 20 recording 7 (see figure 7.2). The dense cover was primarily made up of *Melaleuca cuticularis* and *M. densa* with very little under storey.

The shoreline transect end plots 1 – 7 recorded cover of 3 – 6. Plots 1 – 5 contained little upperstorey and the native under storey vegetation was composed of *Sarcocornia blackiana* (Samphire) and *Juncus krausii*.

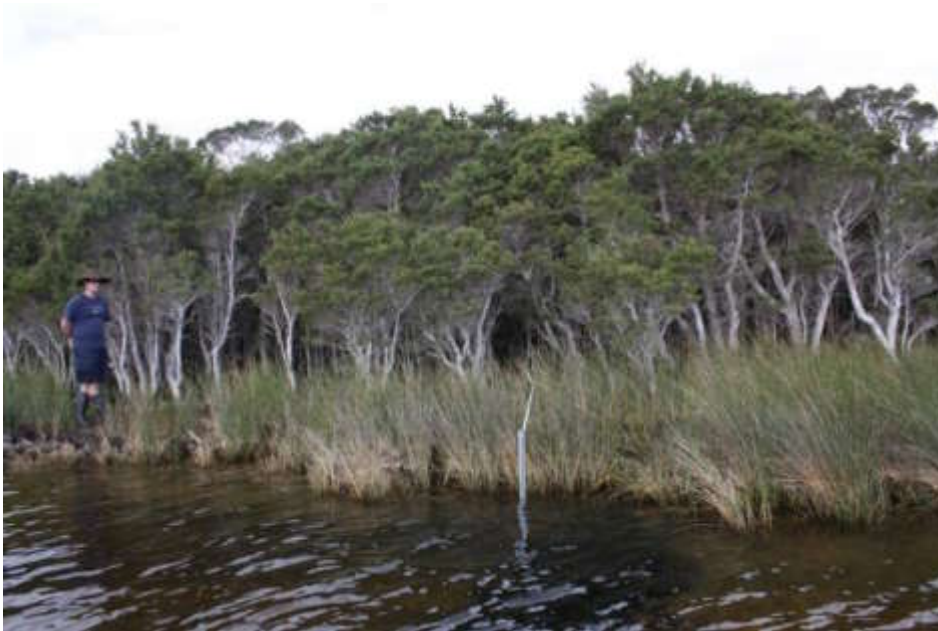
Photo 7.1 Hay River transect line

Flora species: As mentioned before, dense upperstorey of *M. cuticularis* and *M. densa* dominated the latter section of the transect line with little understorey, while along the shoreline section of the transect understorey species, *Sarcocornia blackiana* (samphire) and *Juncus krausii*, dominated with only a few of the upperstorey species present. It was noted that there were a number of dead younger *Melaleuca densa* at the transition zone.

Flora species: The dominant native species at the shoreline end was *Sarcocornia blackiana* (Samphire) and further inland, stands of *Melaleuca cuticularis* and *M. densa* dominated with little understorey. There were some signs that *M. densa* closer to the shoreline were stressed (see photo 7.1) but overall the vegetation looked healthy and unlike a number of other transect sites, the introduced *Paspalum spp.* (Couch) and *Chenopodium spp.* (Goosefoot) species were almost absent.

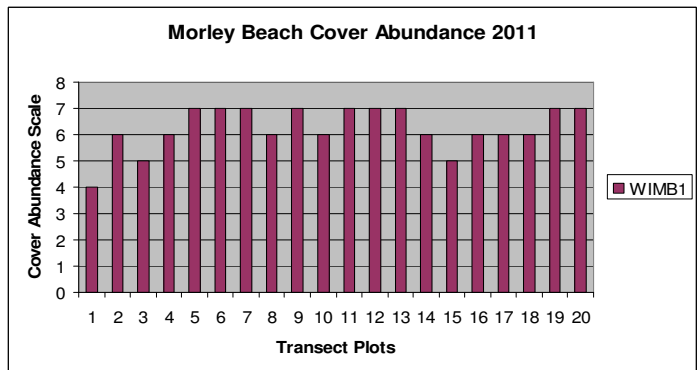
Figure 8.2 Morley Beach Cover Abundance

Cover Abundance: Was generally high, with 6 - 7 cover for all plots except for plot 1, 3 and 15 which recorded 4, 5 and 5 respectively (see figure 8.2).

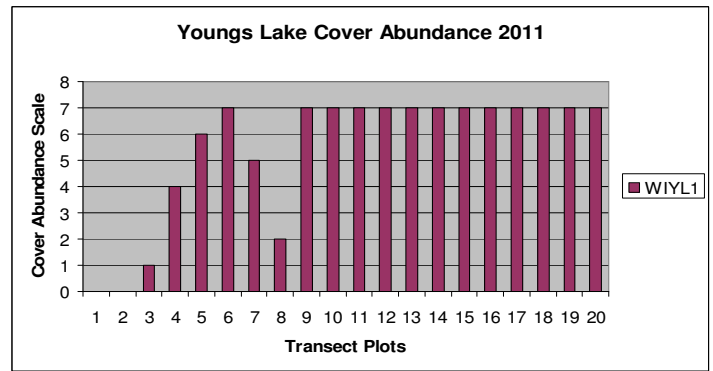
Figure 9.2 Youngs Lake Cover Abundance

Cover Abundance: Showed a general trend of increasing Cover Abundance values from shoreline to inland (see figure 9.2). Plots 1 and 2 recorded no vegetation but a number of granite rocks, so “not applicable” was recorded. Plots 3 – 8 ranged from 1 to 7 and plots 9 – 20 all recorded 7.

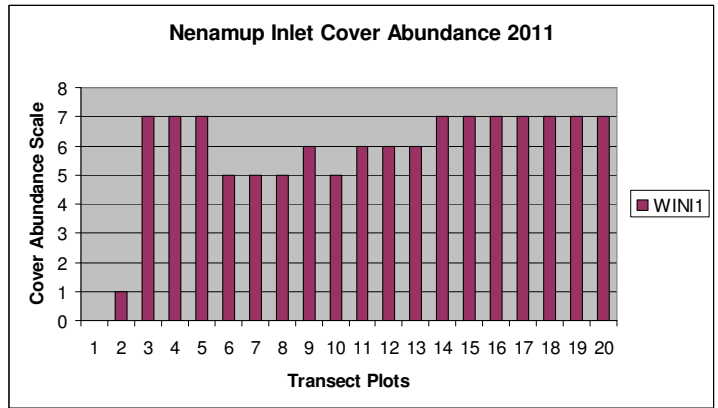
Figure 10.2 Nenamup Inlet Cover Abundance

Cover Abundance: Was reasonably uniform, particularly at the inland end where plots 14 – 20 all recorded 7 (see figure 10.2). The lowest Cover Abundance values were recorded at plot 2 with a grading of 1. Plot 1, due to no vegetation and underwater, was “not applicable”. Between plots 3 – 13 the abundance cover ranged from 5 to 7 with no correlation to water depth, i.e., plots 3 – 5 recorded 7, plots 6 – 8 recorded 5 and plots 9 – 13 recorded 6.

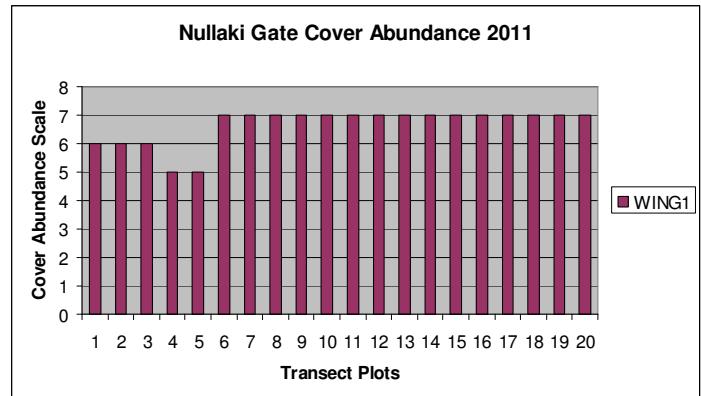
Figure 11.2 Nullaki Gate Cover Abundance

Cover Abundance: Was uniformly high, with only plot 4 (cover value of 5) recording a value less than 6 (see figure 11.2). As mentioned before, cover for plots 1 – 12, except for 5 plants, was only made up of the introduced Couch grass species. There was little upperstorey cover with a large number of dead trees.

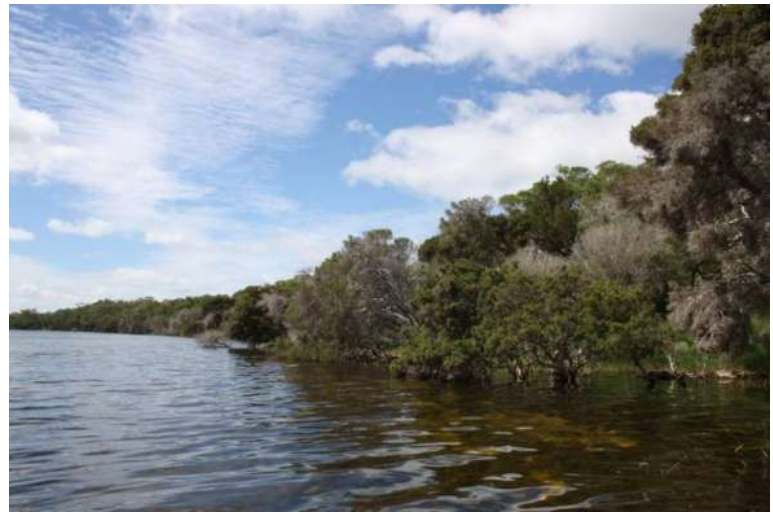
Flora species: Understorey species *Juncus krausii* and *Rhagodia baccata* became more prevalent in the latter inland section of the transect (plots 13 – 20). Of the upperstorey there were none recorded along the actual transect; however there were a large number of tree deaths within the inundation area, (approximately 50% as a guideline). Dead species included *Melaleuca densa* and one *Agonis flexuosa*. All *M. densa* within 8 meters from the shoreline were dead. The dead trees appear to have died over 12 months ago as all the leaves are missing from them. Other *A. flexuosa* are also showing signs of stress (area between shoreline and Eden Road).

Photo 11.2 Nullaki foreshore looking east from transect
